# Climbing Wall Inspection Report

**Company Name** Funday entertainment

**Client Name:** Tony

**Date of service** Tuesday, April 14, 2026

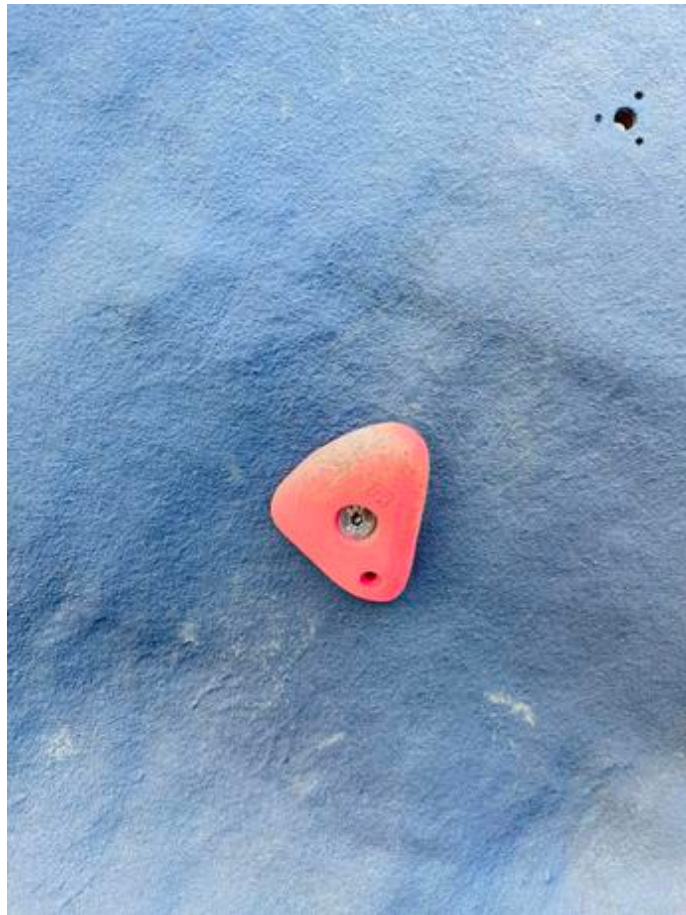
**Photo of holds.**

Good condition

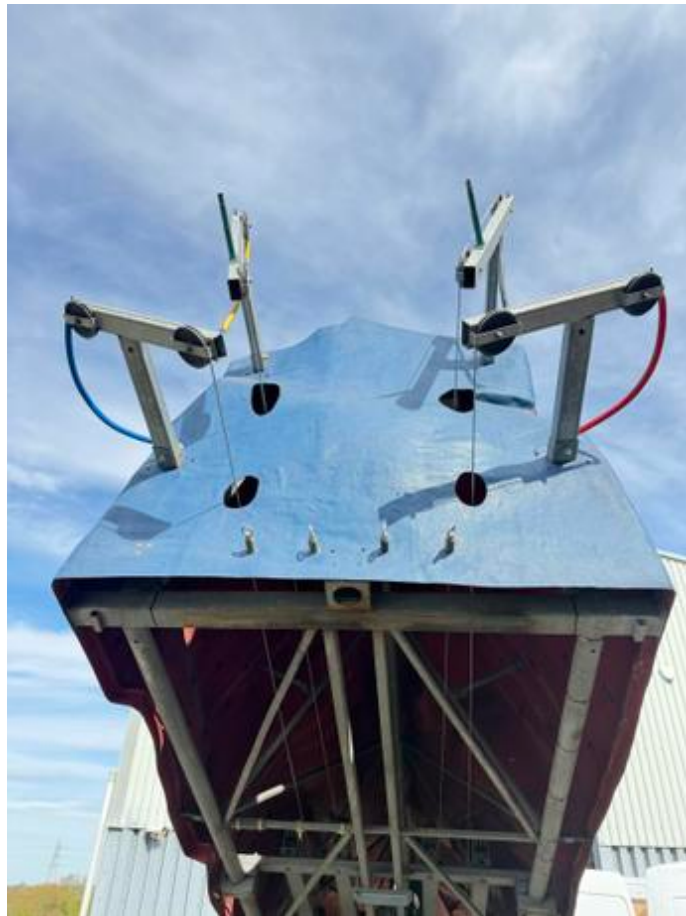
**Photo of fixing points**

Yes

4 inch box steel

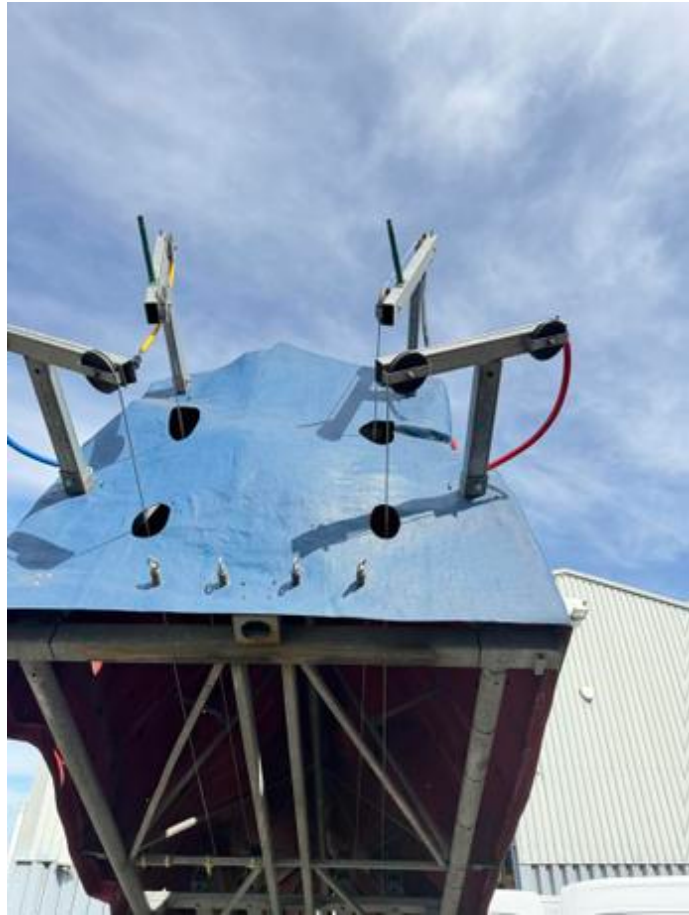
**Photo of belay fixing points**

None

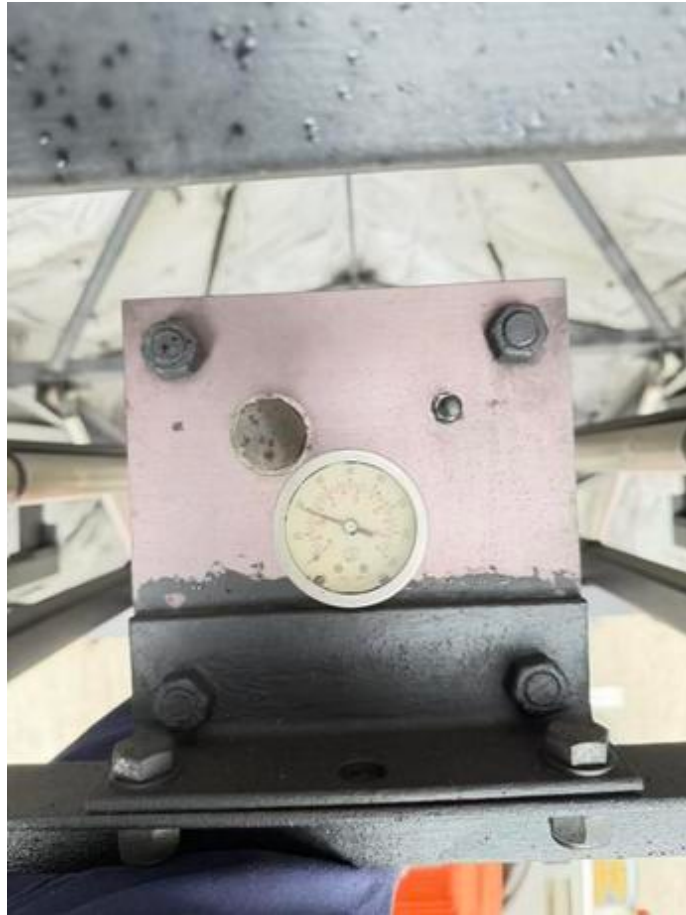
**Photo of pressure gauges**

Yes

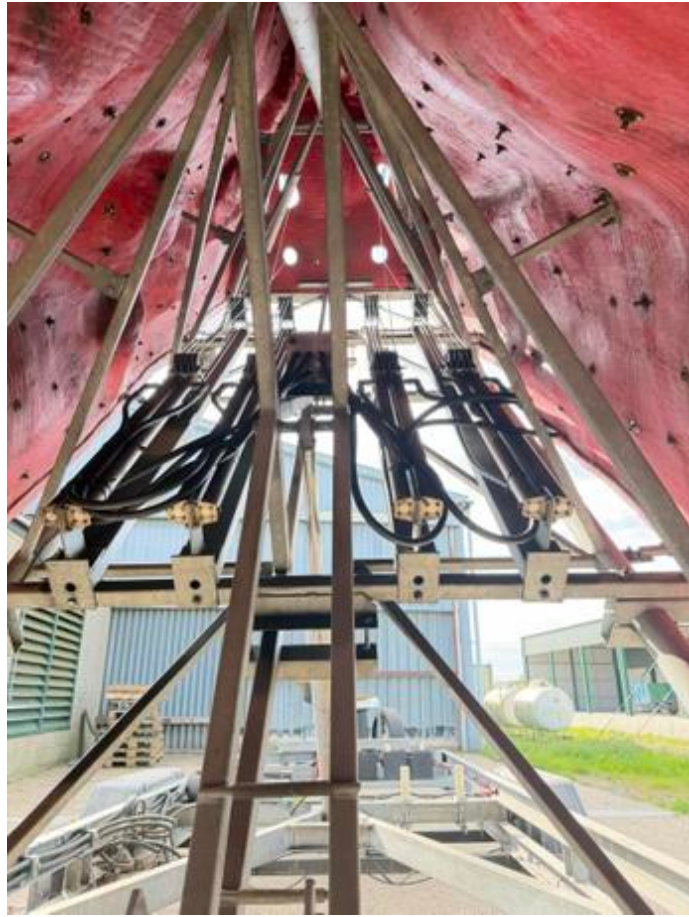
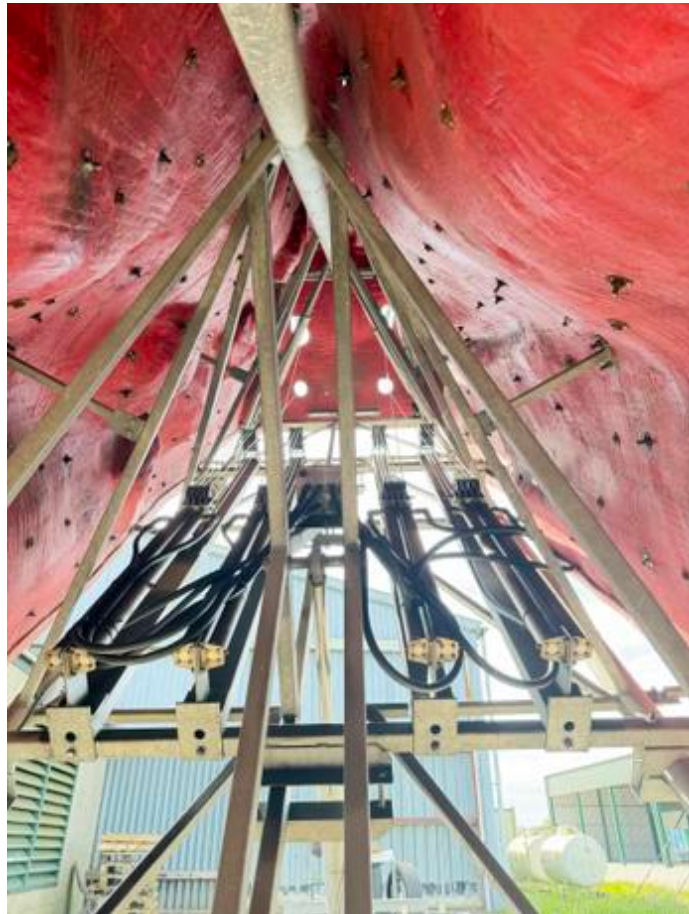
**Photo of belay rams**

In good condition

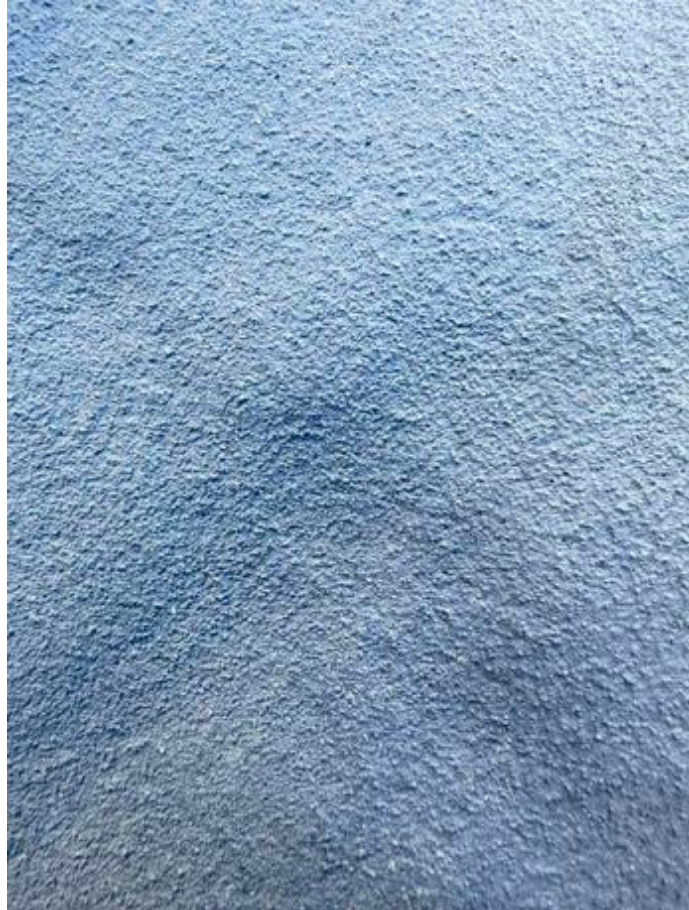
Photo of wall surface

None

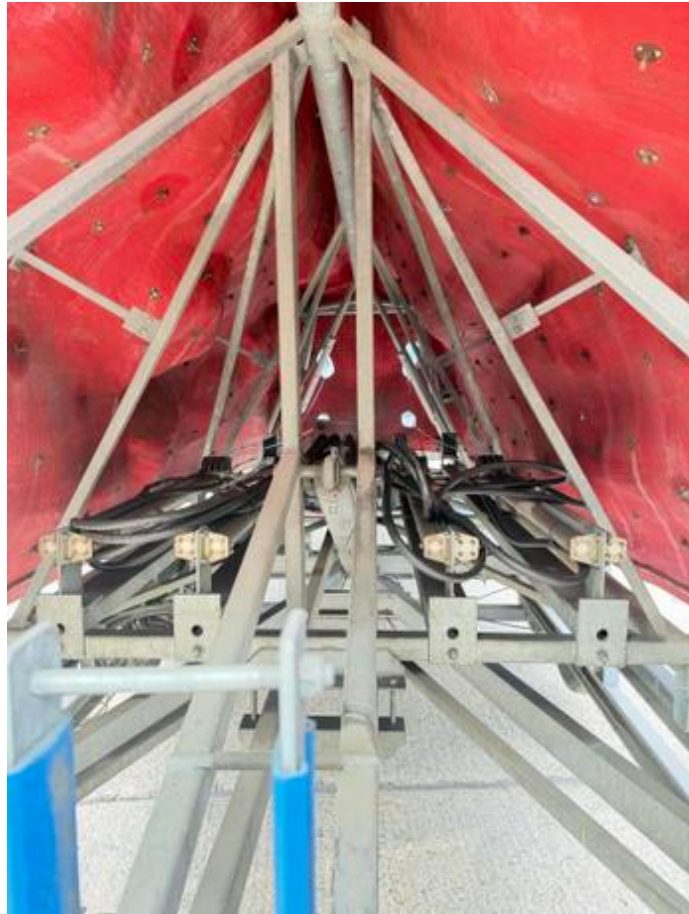
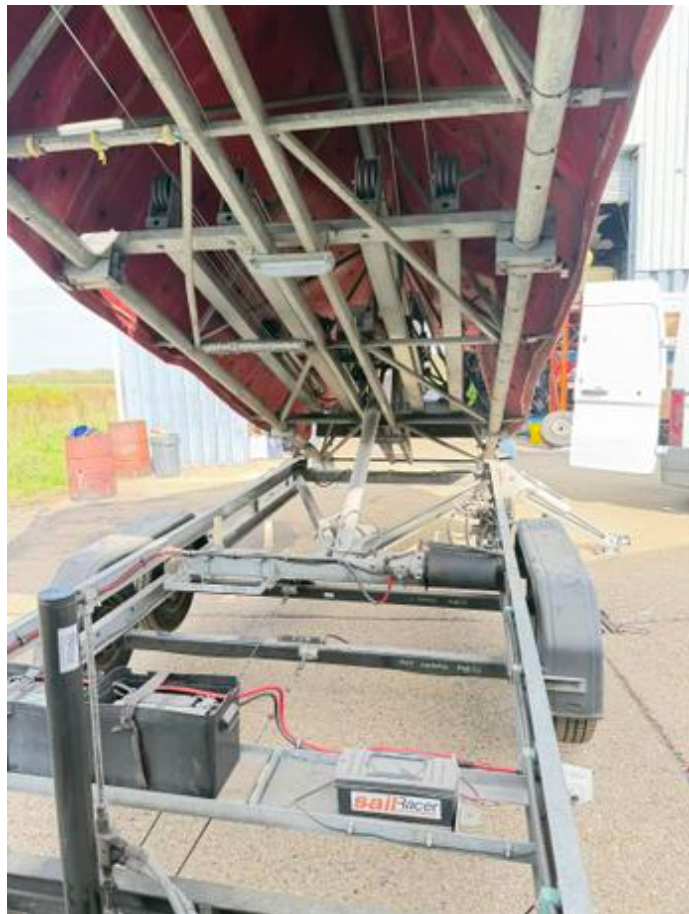
Photo of substructure if accessible or surrounding areas

good

Yes
